File No. 437-42

Docket No. SA-63

REPORT OF THE CIVIL AERONAUTICS BOARD

On the investigation of an accident involving aircraft of United States registry NC 16064 which occurred at La Guardia Field, Jackson Heights, New York, on April 11, 1942.

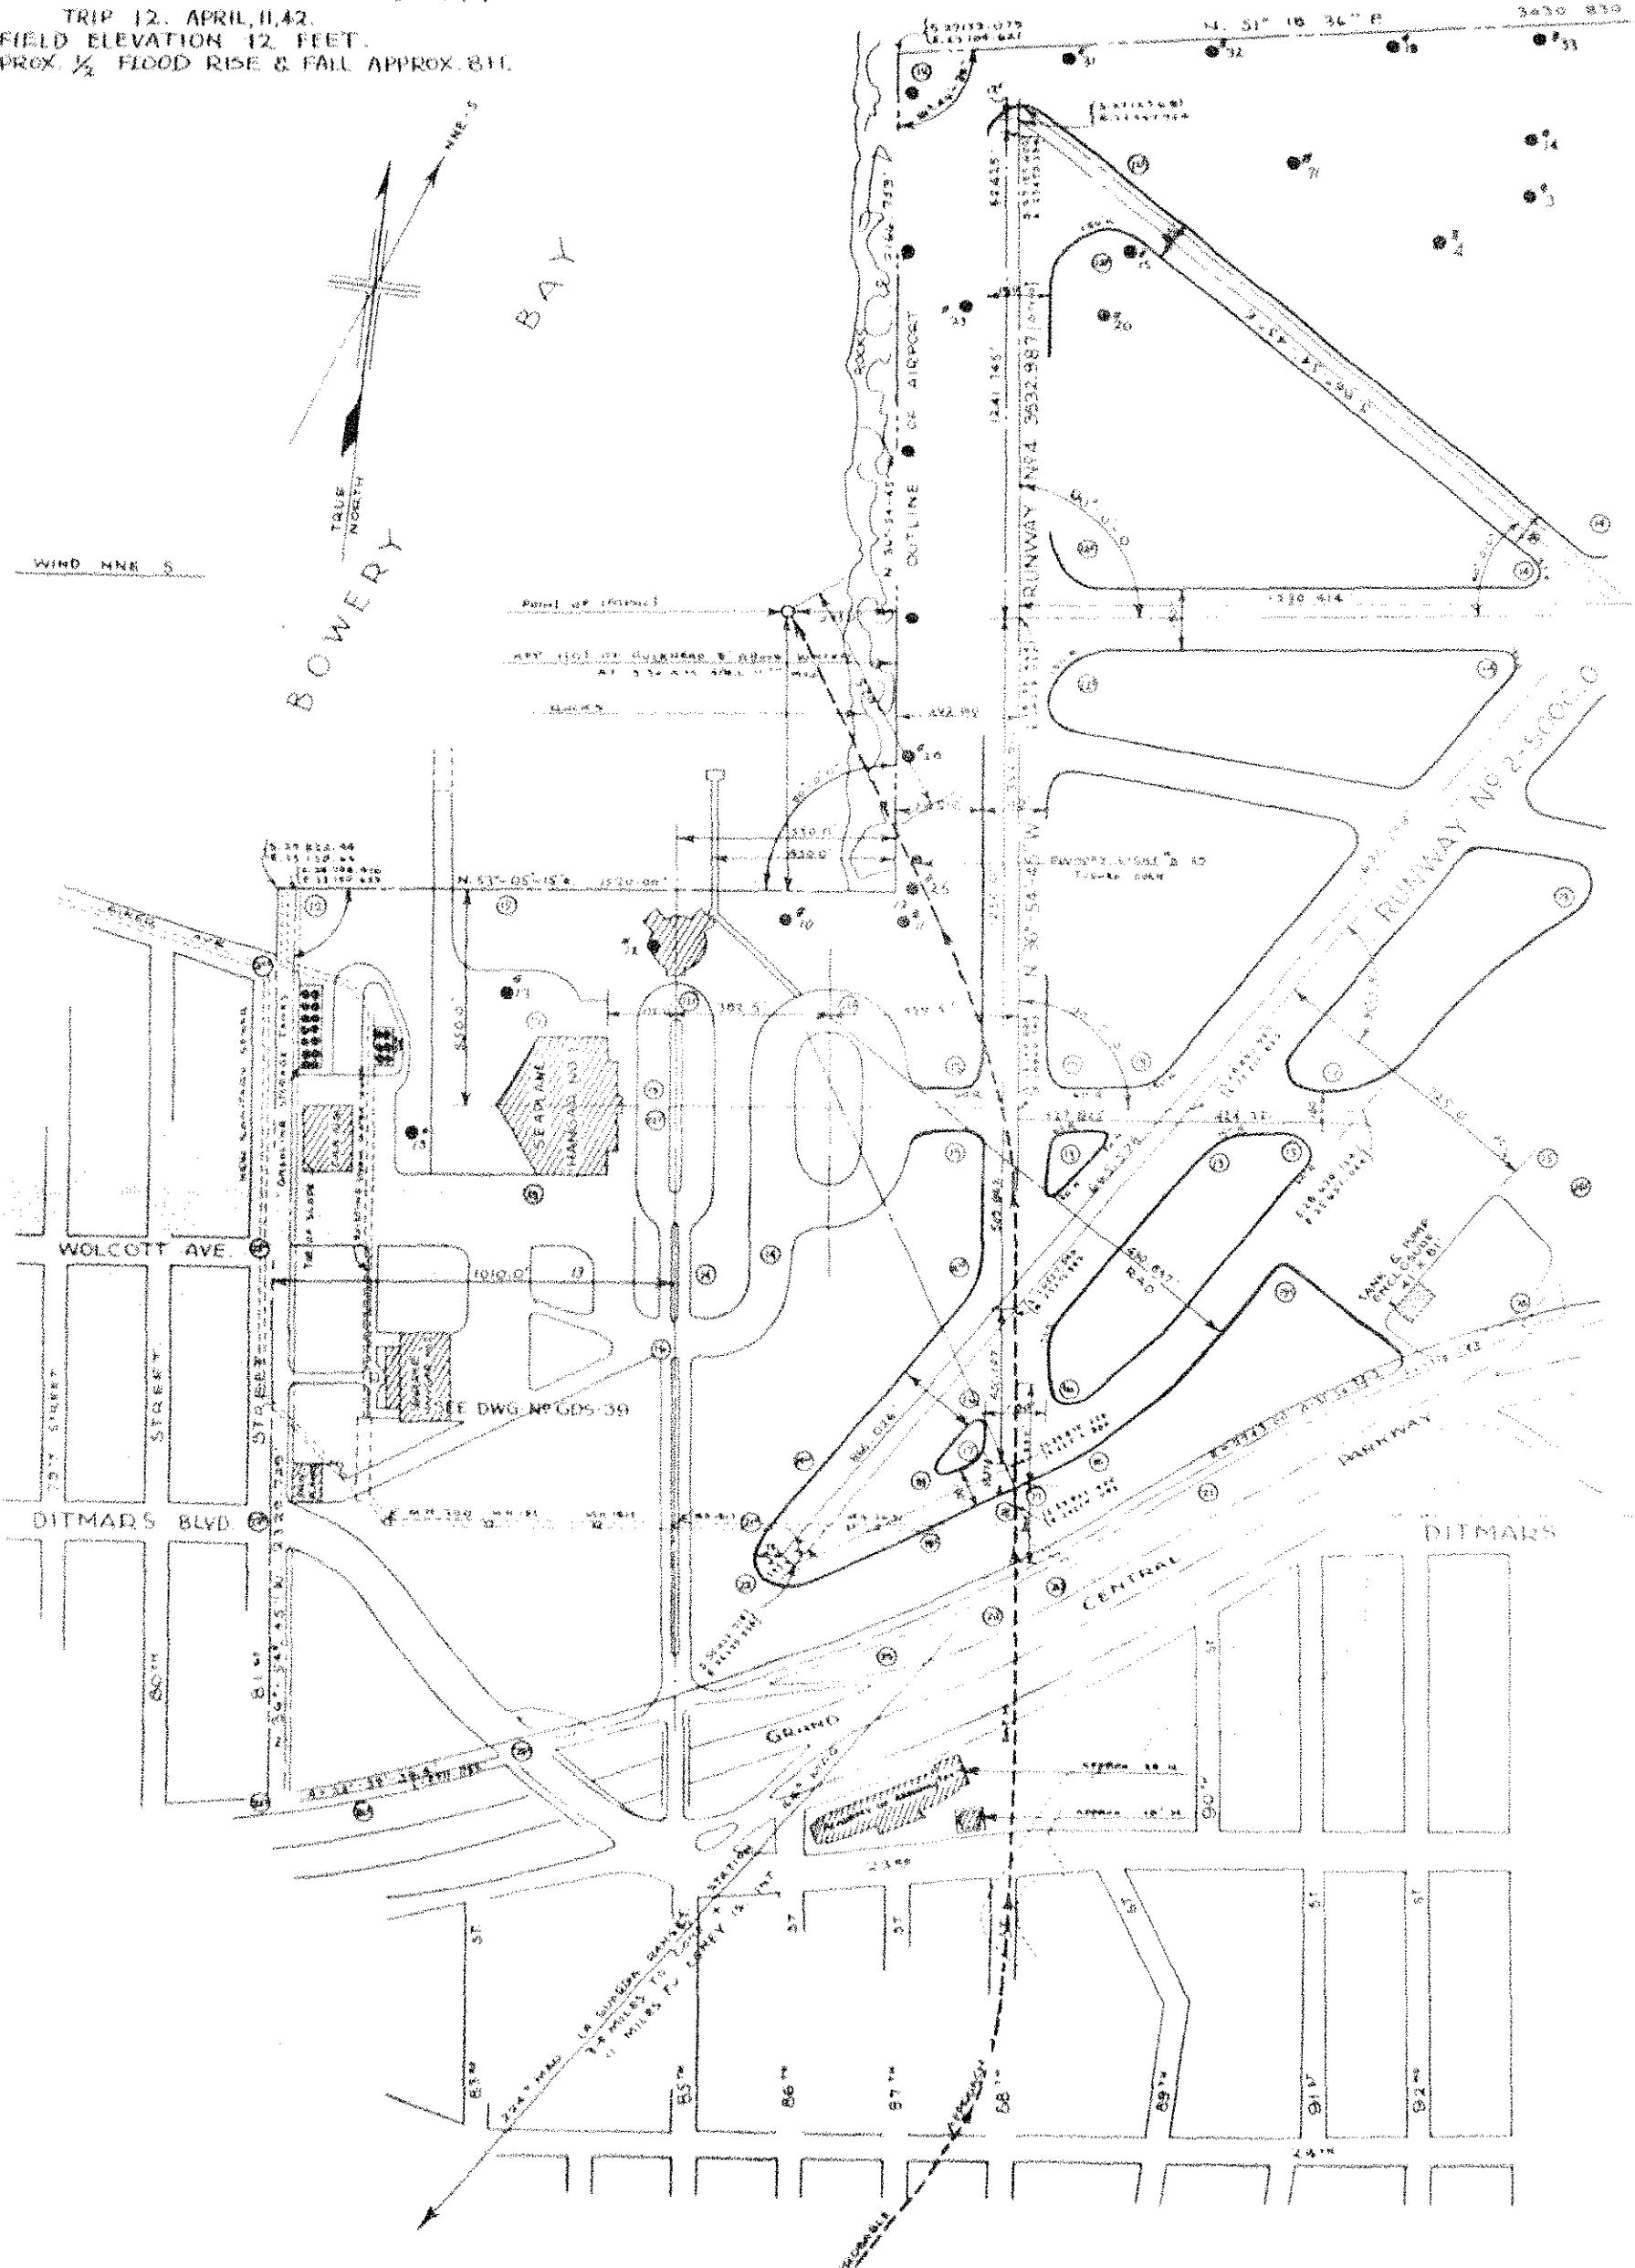
UNITED AIR LINES ACCIDENT

TRIP 12. APRIL 11, 42.
FIELD ELEVATION 12 FEET.
TIDE APPROX. $\frac{1}{2}$ FLOOD RISE & FALL APPROX. 8 FT.
